Risk of skin reaction when using ECG electrodes

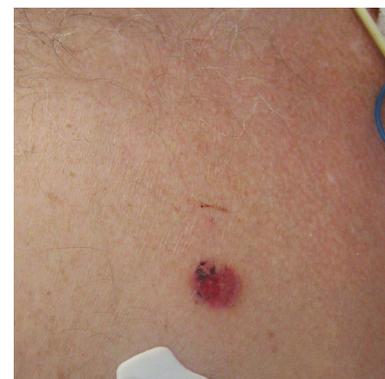
skin burnt under the electrodes, when they are used in Magnetic Resonance (MR).

After the case was investigated, it was concluded that the burning was caused because the electrode wires were forming a loop.

Example of a skin burn under the electrode

- Use the electrodes as suggested in the Directions for Use.
- Do not use electrodes for adults in children.
- Blue Sensor MRX-electrode: do not make cable loops inside MR-scans.
- If skin preparation is needed, avoid using sandpaper.
- If the electrode is strongly adhered to the skin, use drops of water to facilitate electrode removal.
